Earth plaster as a means of salt reduction in historical brick and natural stone masonry – Principles, mechanisms and experience

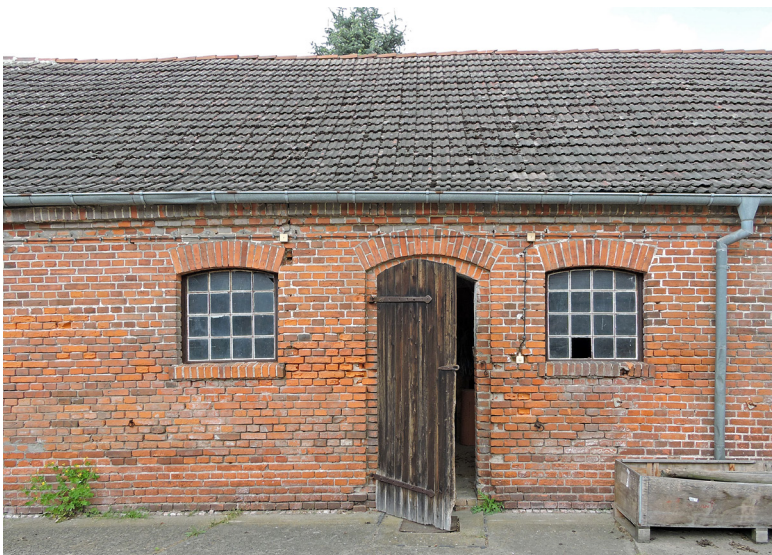
01 Former stable building with clear indications of moisture and salt load on the brickwork

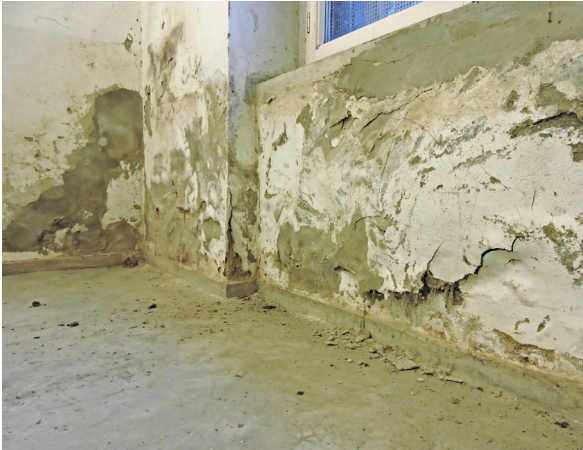
02 Restoration plaster after a service life of 10 years without installation of a horizontal barrier

restoration plasters merely delay the recurrence of dampness and salt contamination problems. Depending on the specific conditions of the building, these products buffer salts in their pore cavities for the short to medium term – typically 3 to 10 years – before the surface effects of salt contamination recur.

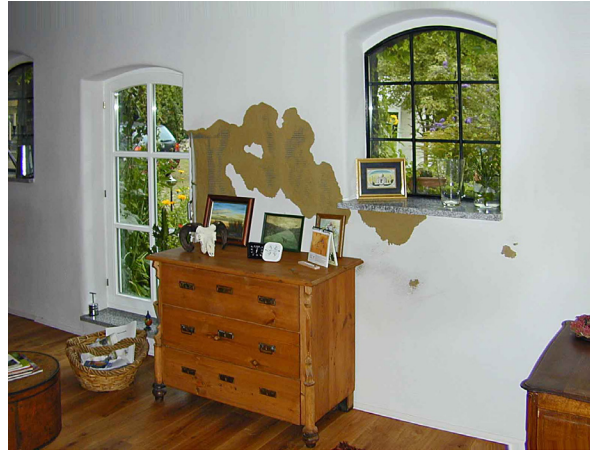
04 Even after installing a horizontal damp proof course, damage can still occur if no salt reduction measures are undertaken

Similarly, if salt reduction is omitted, it is highly probable that salt damage to the surfaces will recur again despite the installation of a horizontal barrier.

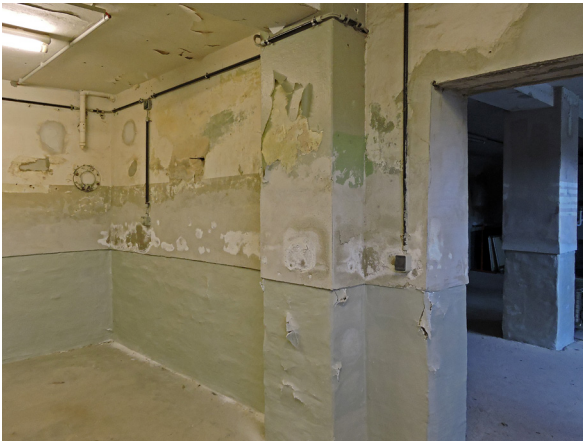
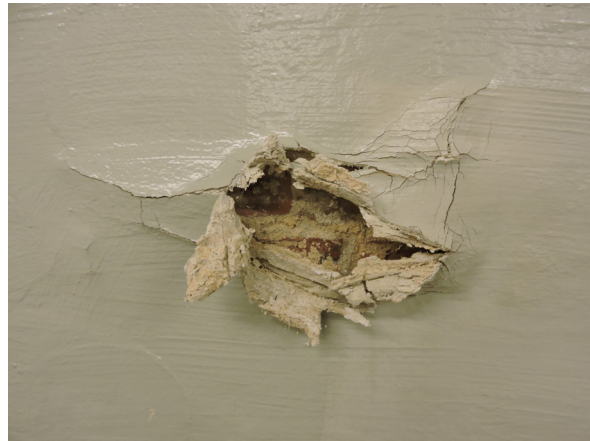
03a and b The "restoration" of a basement using barrier plaster without installation of a horizontal barrier. 5 years on, the evaporation zone has shifted upwards and the coating has burst open.

Barrier coatings only displace the moisture horizon, causing damp to rise higher in the wall, in turn increasing the extent of damage.

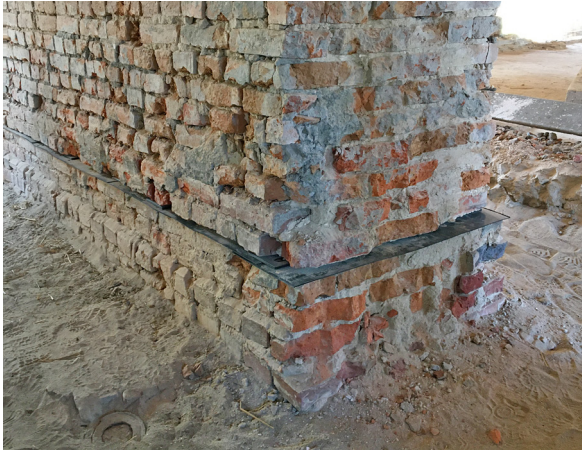
05 Installation of a mechanical horizontal barrier using the wall sawing method as a preparatory measure for desalination

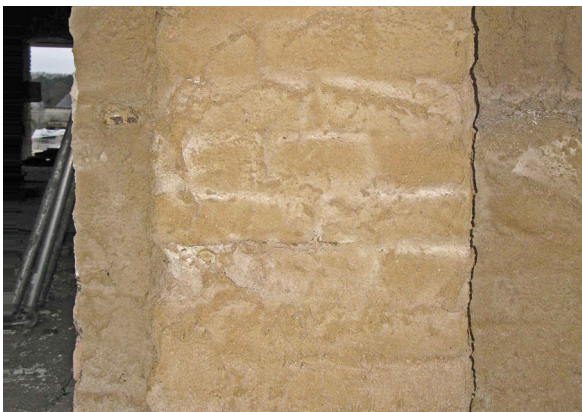
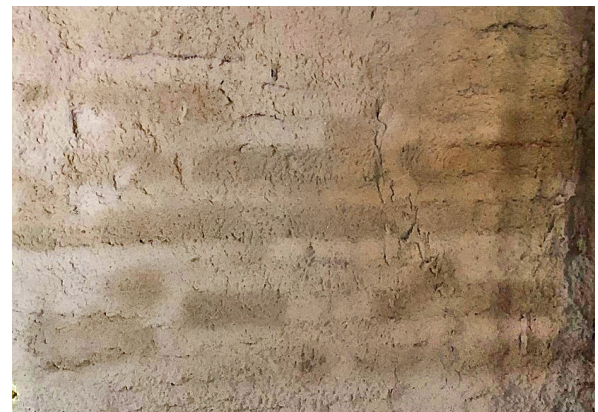
06a and b Salt penetration into the sacrificial plaster can be seen as whitish salt deposits on the surface or dark areas that do not dry out. Depending on the type and combination of materials in the existing structure, the salt concentration may be higher in the masonry mortar (left) or in the bricks (right).

- damp areas that do not dry due to the hygroscopic (water-binding) properties of the salts, or
- whitish surface efflorescence.

Both characteristics are particularly apparent when using traditional earth plasters due to the darker brown colour of the plaster. In areas where salt ingress is particularly evident, the salt concentration of the base wall may still be significant, and the process should be repeated accordingly.

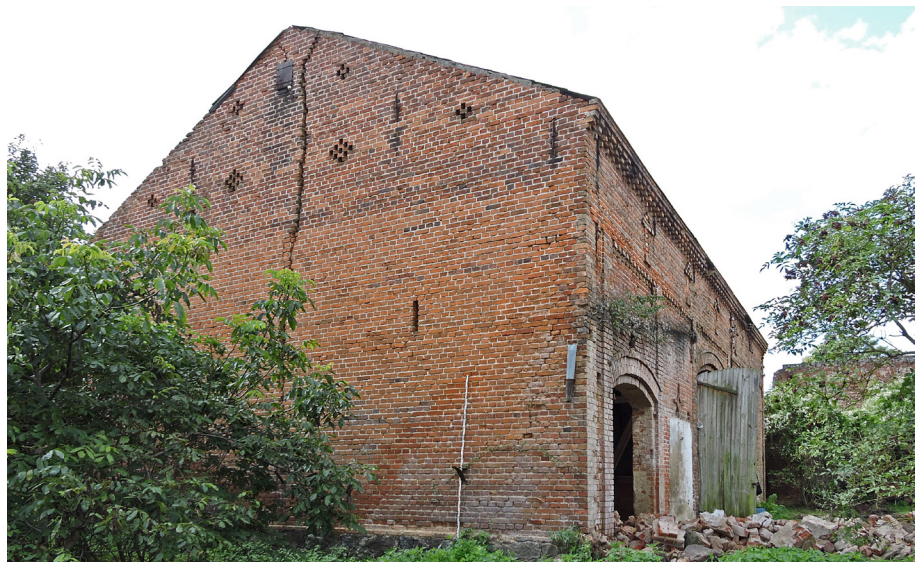
07a Barn in Weesow: View from outside showing clearly visible moisture and salt damage.

The building structure exhibited high to very high levels of moisture and salt content in some areas due partly to its construction, age, lack of upkeep and not least its partial use for keeping livestock. In these areas, the nitrate values were up to six times higher than the recommended maximum values outlined by the WTA.

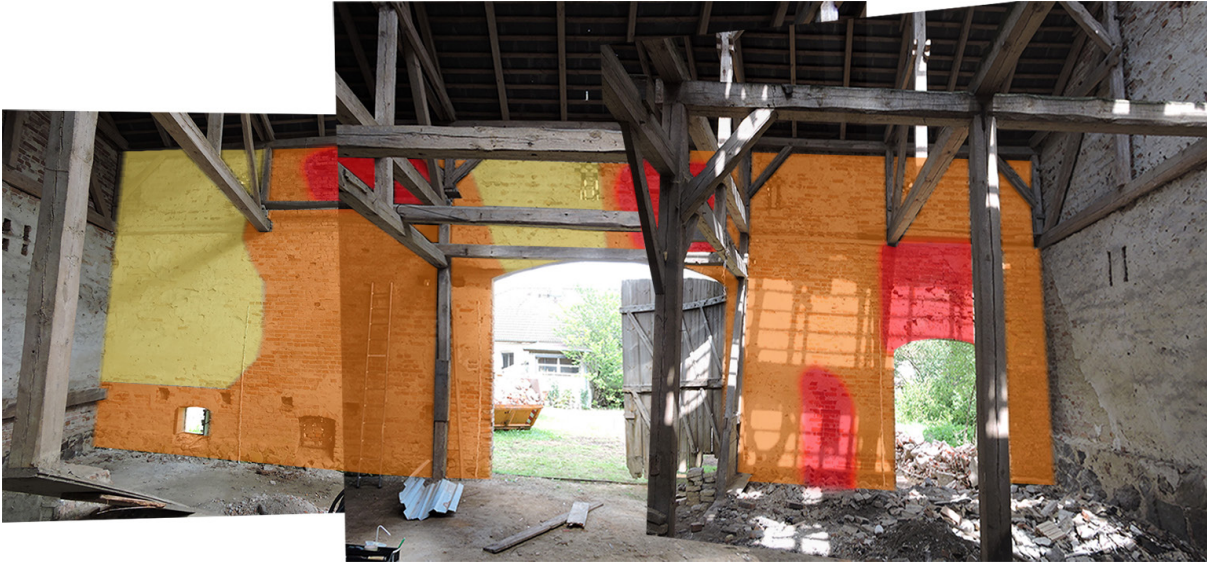
07b Barn in Weesow, D: Interior with areas of supercritical salt contamination marked

At relevant locations, a height and depth profile of the moisture and salt load was established by taking samples at 5 (wall) depths and 4 heights. A control value – a so-called zero sample – was also taken from an unaffected wall area. Further samples were taken in specific affected areas, such as where the roofing was defective. The moisture content of each sample was determined at the time of sampling as well as at 23°/50% RLF and 23°/80% RLF in order to clarify the influence of rising and hygroscopically caused increased moisture. The anion concentration of nitrates, sulphates and chlorides was determined from each sample. A cation determination was

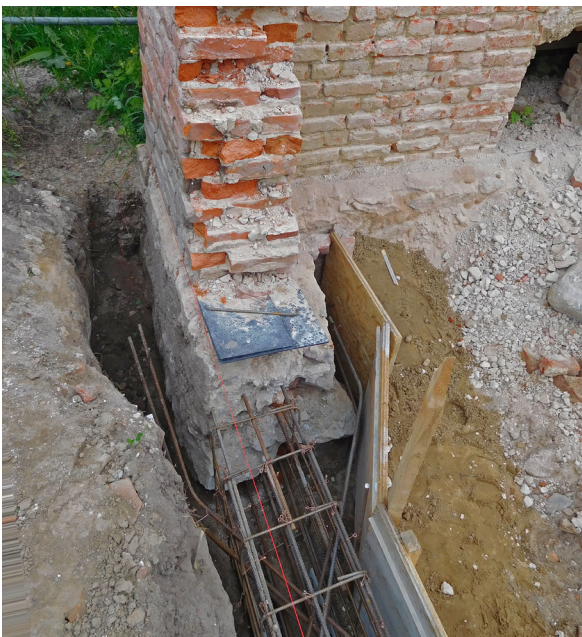
08a Installation of the horizontal damp proofing and local foundation reinforcements

The installation of the horizontal damp proof course was carried out as an advanced measure a whole year in advance of the desalination measures. In areas with extreme salt load, 4 cycles of desalination were required until no further indications of an increased residual salt load could be detected. After desalination, an internal insulation system was applied to a layer of earth levelling plaster. As the existing walls had exhibited dry rot infestation, a mineral internal insulation system was used.

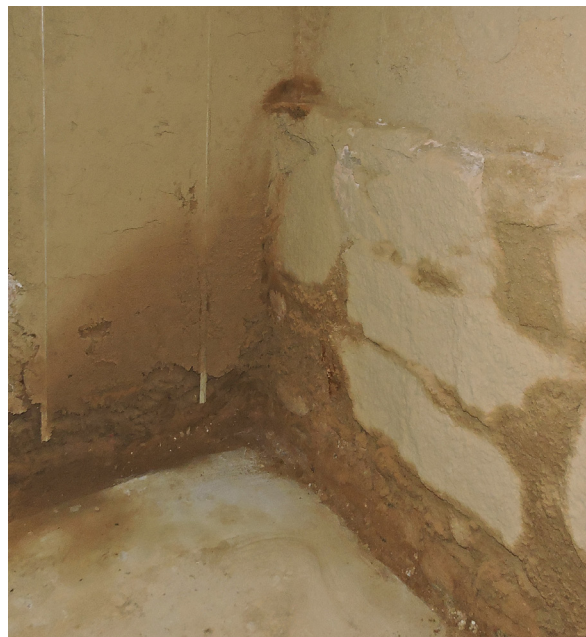
08b Sacrificial plaster with clearly recognisable localised incidence of hygroscopically increased moisture

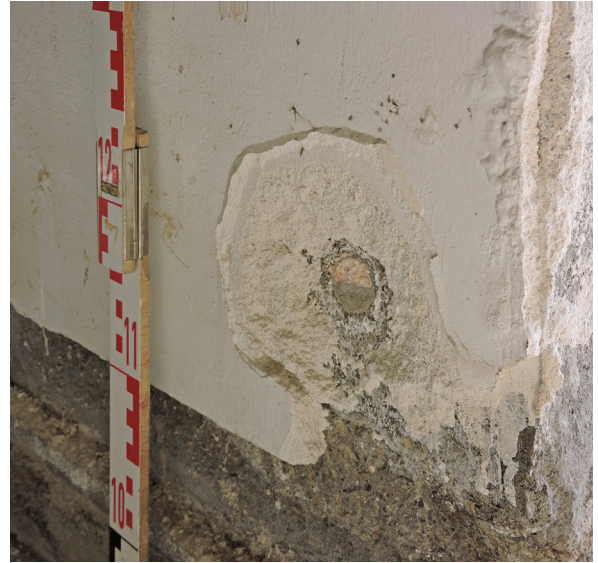
09a and b The injection holes for the 1980s chemical horizontal damp proofing barrier are too far apart. In addition, the injection agent was chemically and physically incompatible with the stone it was injected into.

The historical stone walls were originally built using lime and coral bricks set in gypsum-lime mortar but over the course of many subsequent conversions, new building materials, such as reinforced concrete or cement plaster, were introduced that were not compatible with the original fabric. During a conversion phase in the 1980s, a chemical horizontal damp proof barrier was installed. Testing showed that moisture content levels above and below this barrier layer were roughly the same. Further investigations revealed that the closed pore structure of the original stone inhibited the spread of the injected chemical barrier. In addition, the distance between the injec-

tion holes were, by current standards, too far apart. As a result, the chemical horizontal barrier had been largely ineffective since the very beginning.

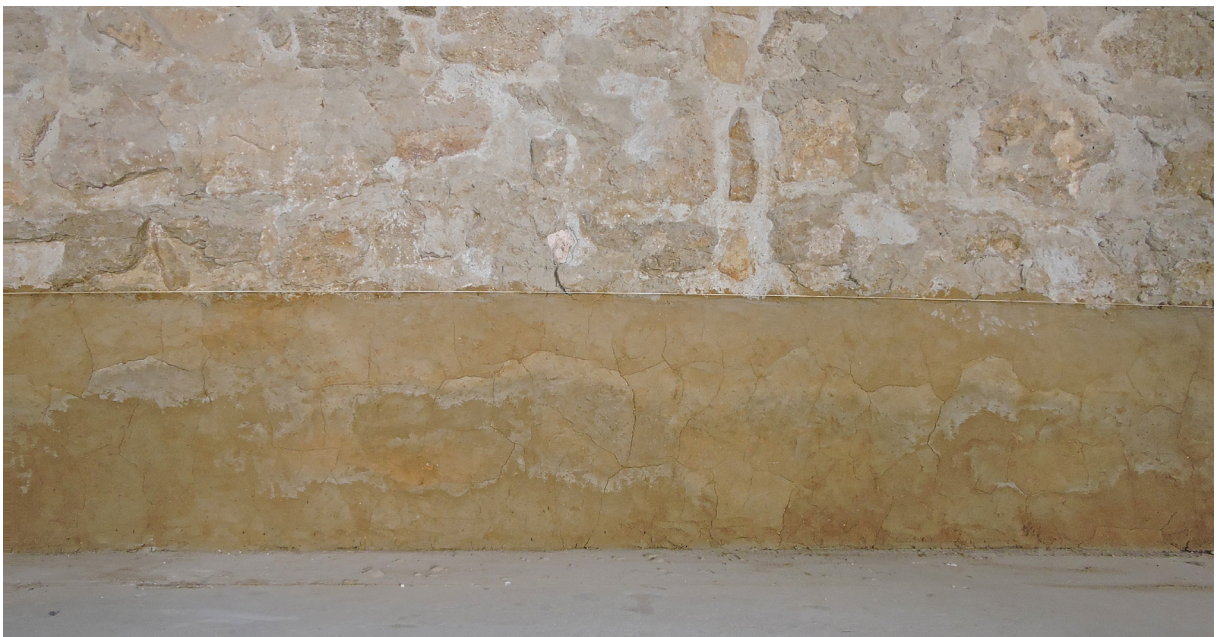
10a Clearly visible indications of desalination during the third cycle of desalination measures

After extensive preliminary investigation of the moisture and salt content in the soil and in the layers of the building fabric, we recommended the installation of a mechanical horizontal damp proofing barrier into the construction. The conservation authorities, however, did not give approval for such significant intervention into the historical substance. As a consequence, the repeated application of clay mortar as a salt reduction measure was undertaken as a means of at least extending the period of time until moisture and salt damage to the plaster surfaces may recur. Due to the lack of locally available suitable earth, a salt reduction mixture of bentonite powder and sand was mixed in a ratio of 1:5.

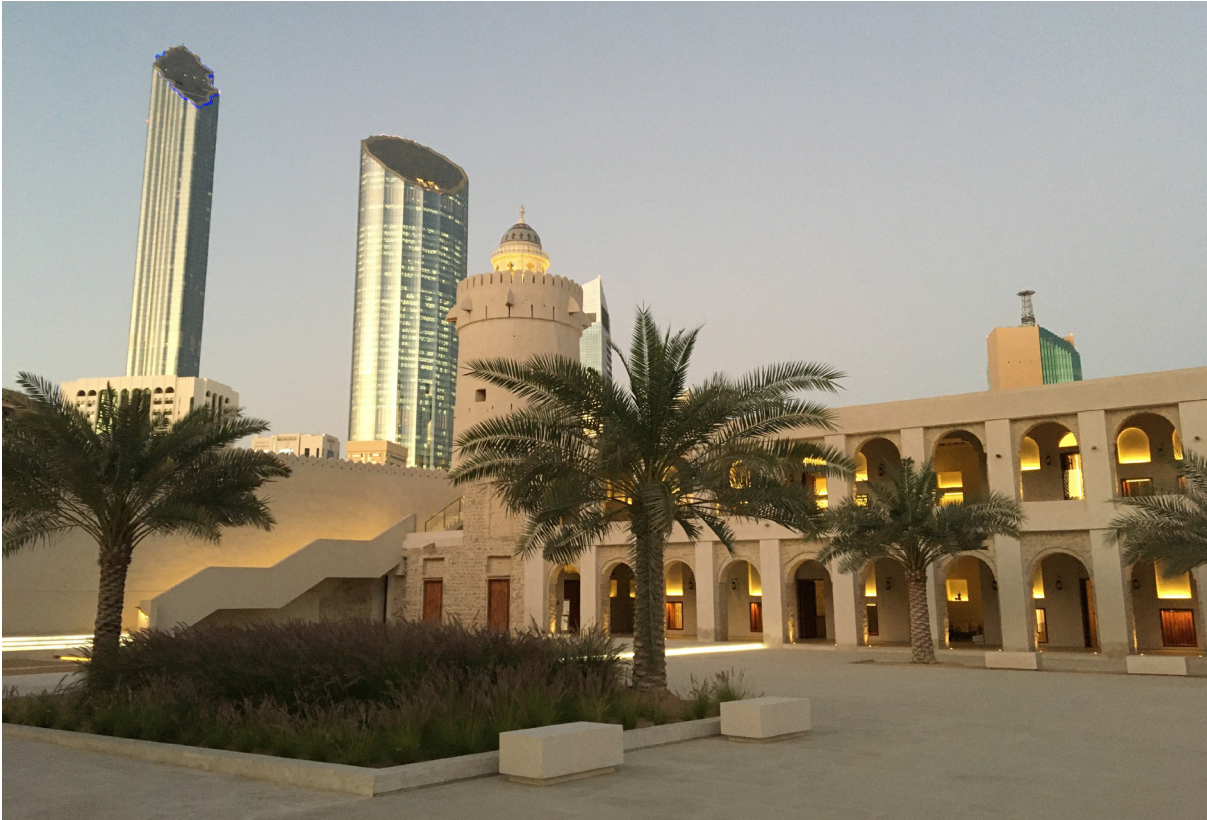
10b Qasr al Hosn, Abu Dhabi, UAE, after completion of desalination works

In January 2020, heavy rainfalls led to a strong increase in water ingress into the walls. Due to the lack of a horizontal waterproofing system, signs of renewed salt contamination have therefore already reappeared in the lower base area. Under normal environmental conditions, this had been predicted for a much later time horizon.
